Aidan Tuckett B.Sc.(Hons).

MARINE SURVEYOR

REPORT OF A CONDITION SURVEY CARRIED OUT ON THE VESSEL:

“ [REDACTED] ”

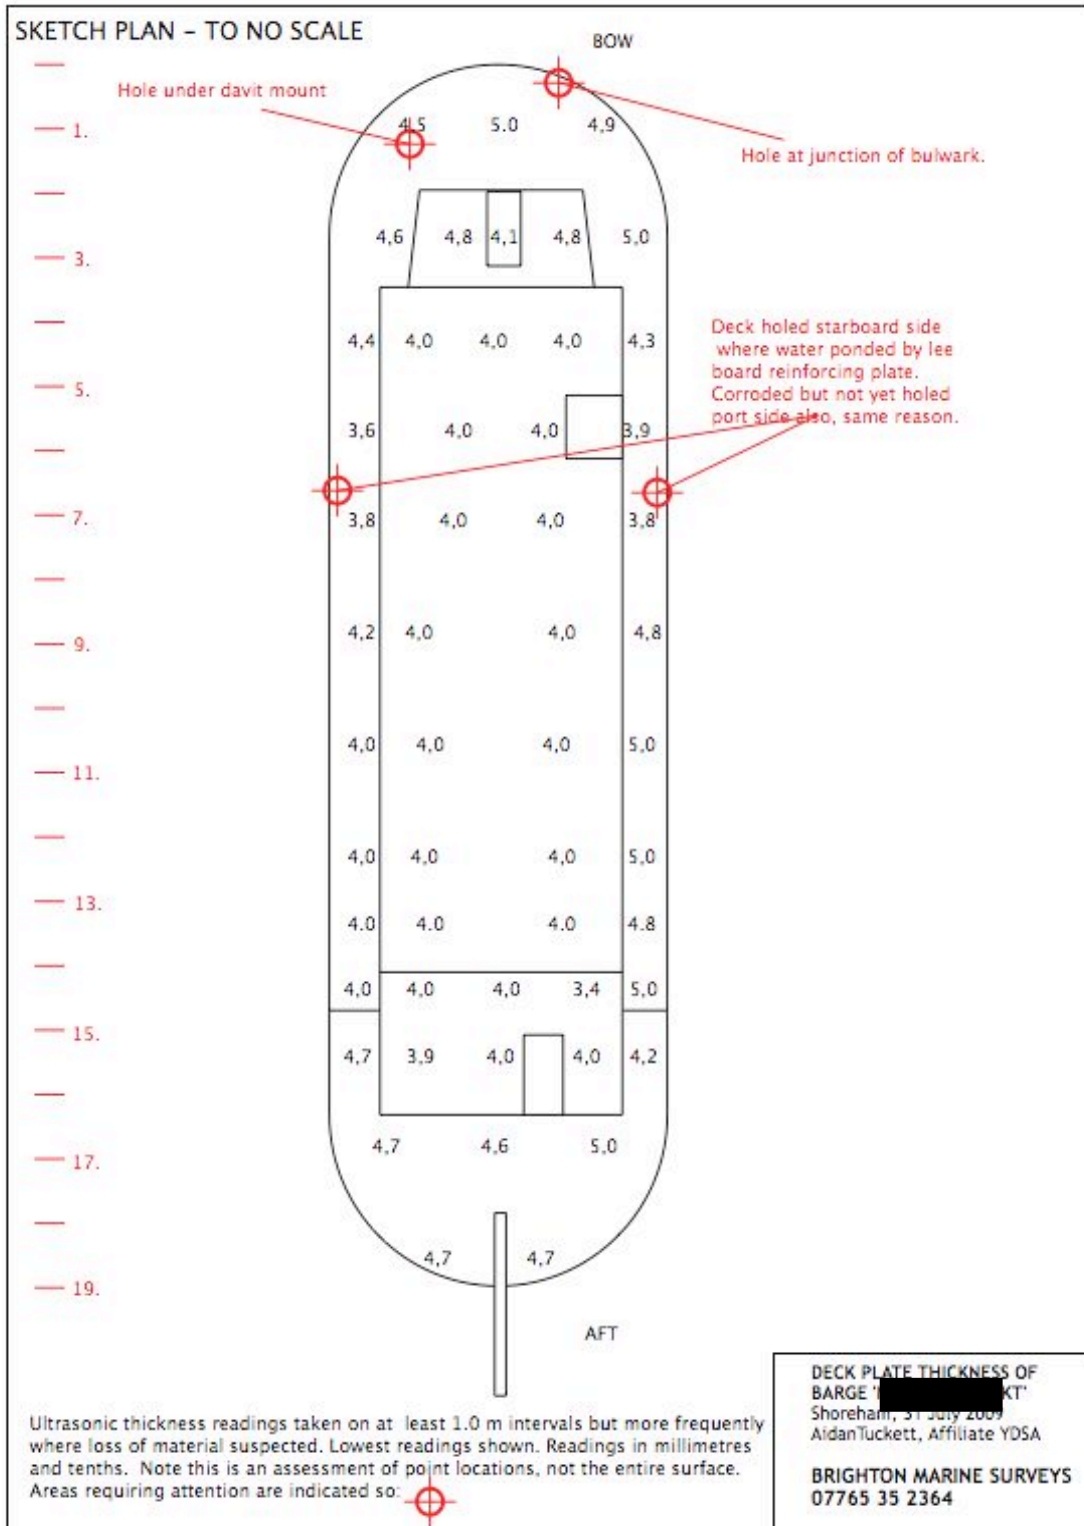
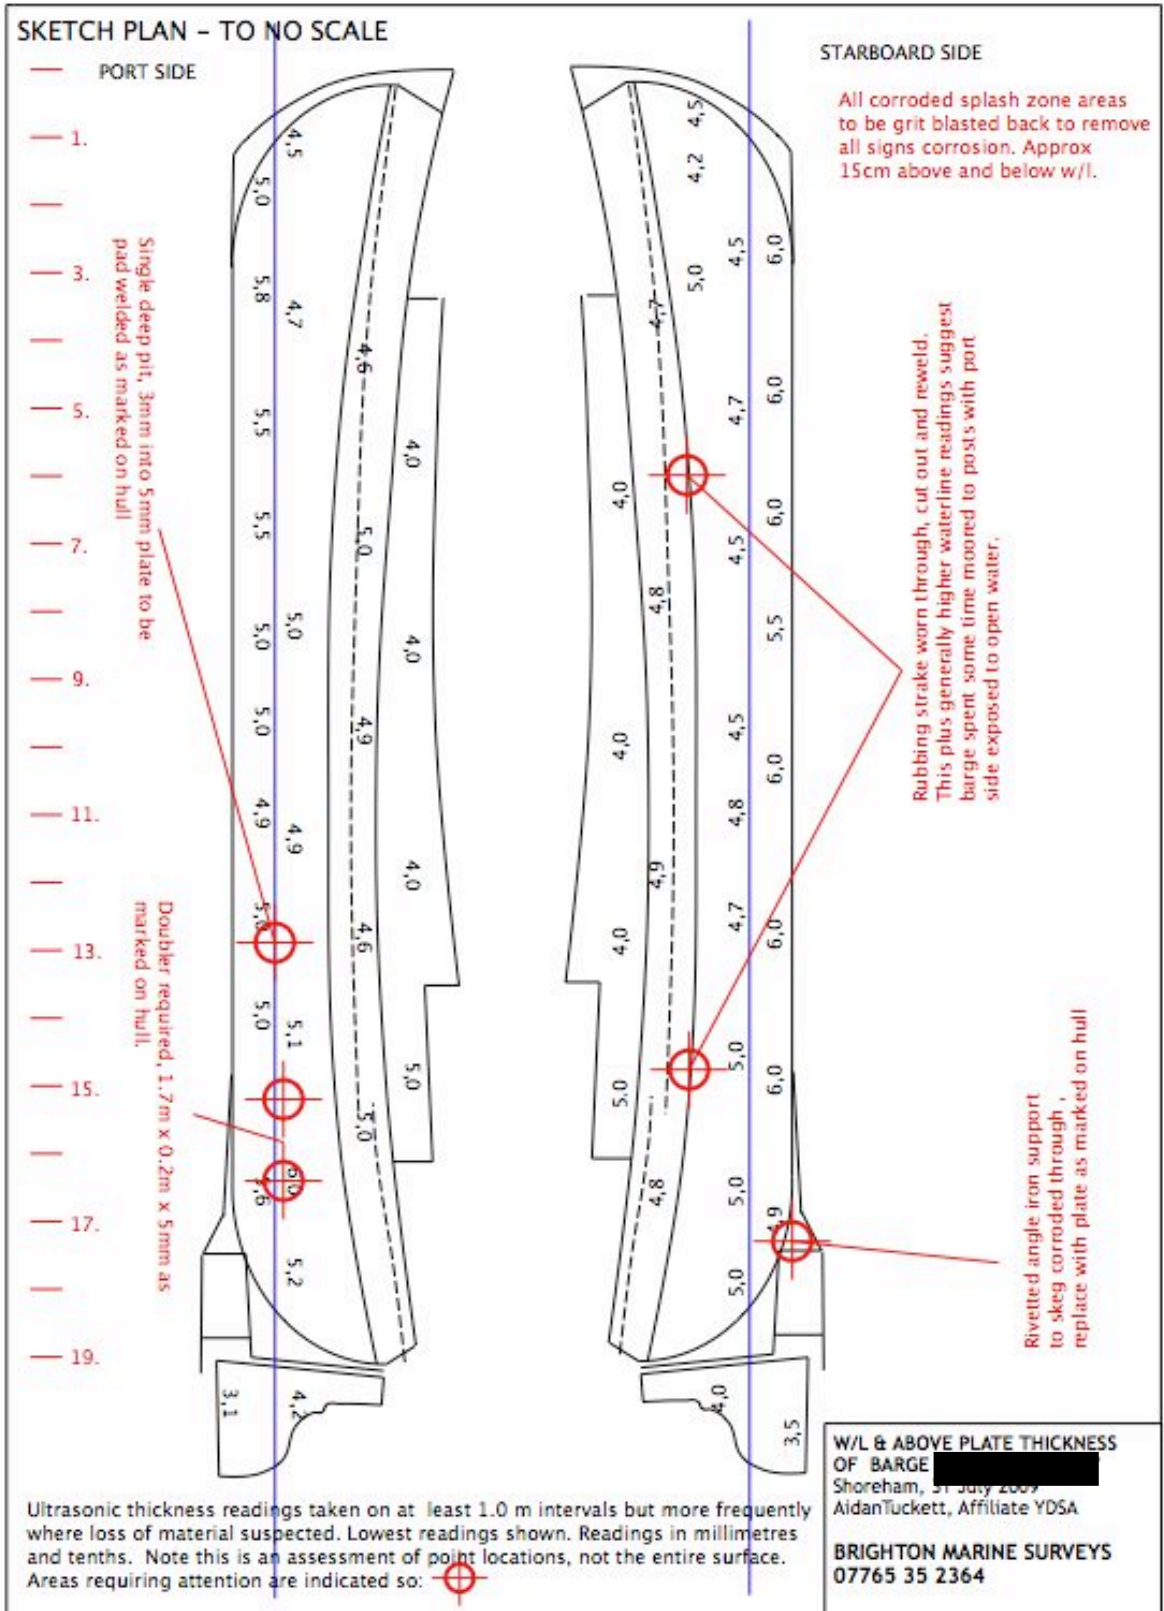
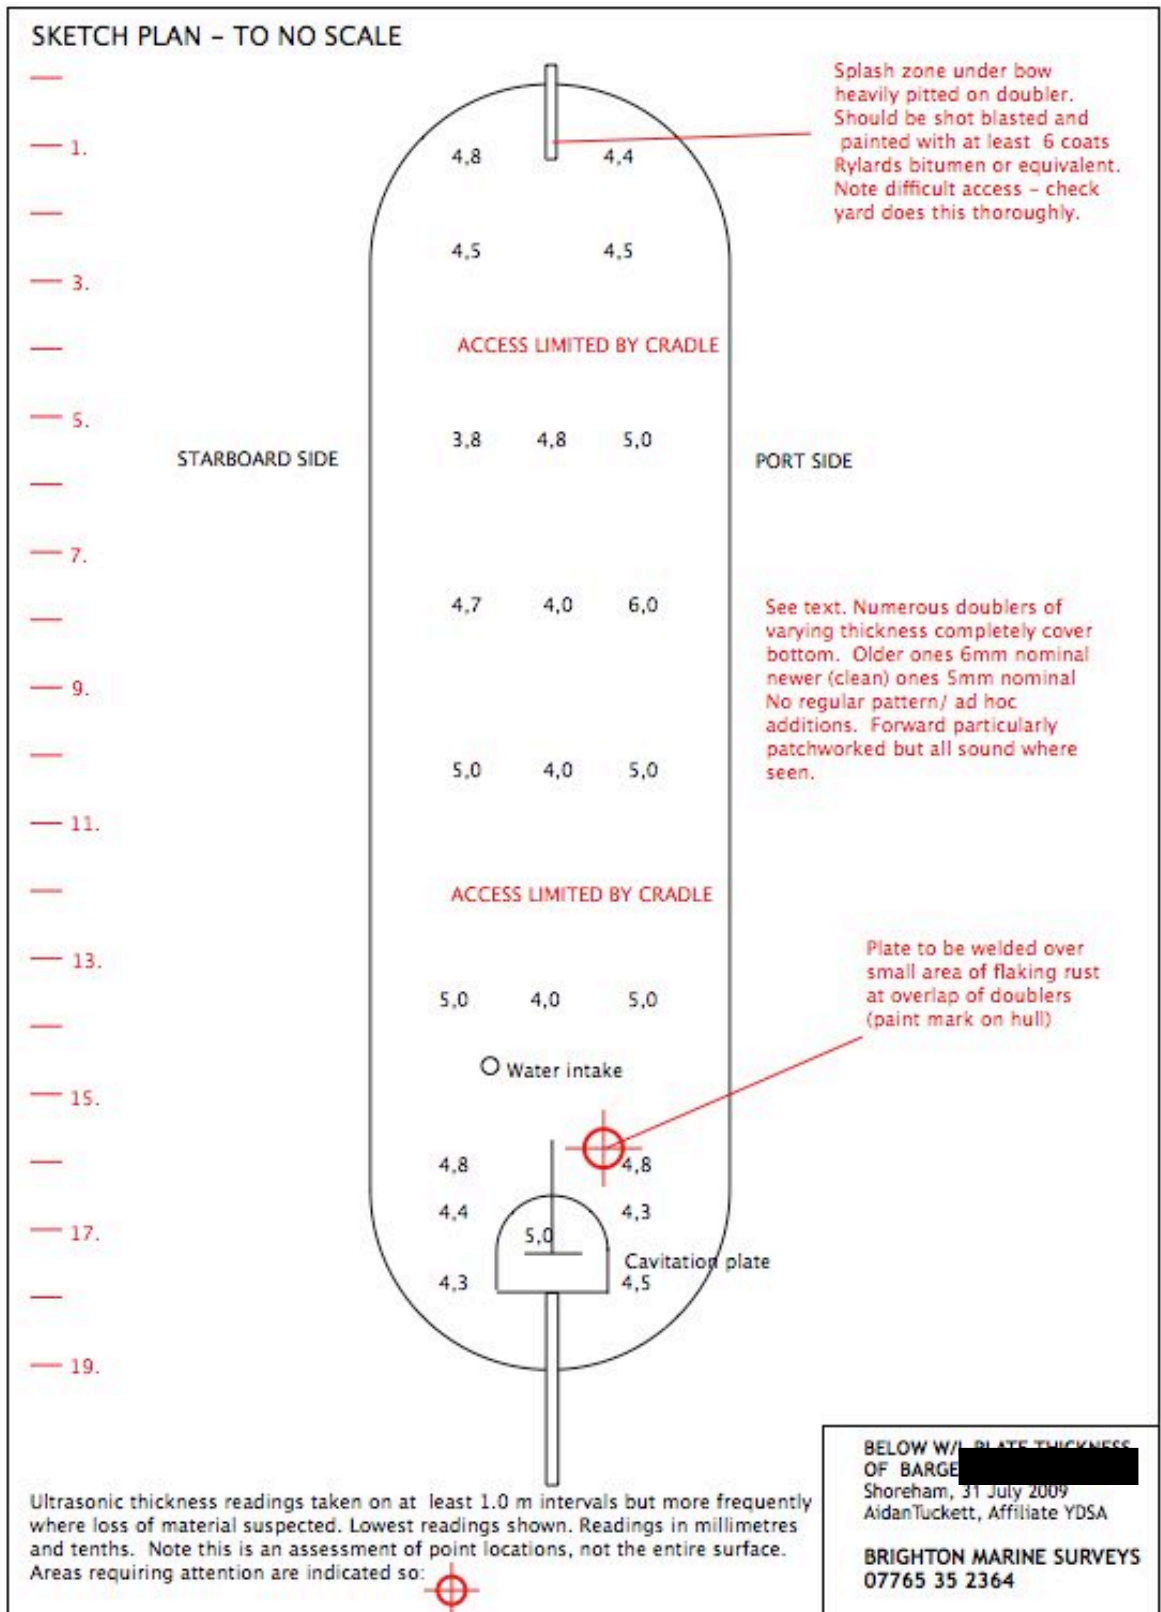
D. Hull, Deck and Structure.
 D1. Ultrasound survey

Corroded areas requiring attention are mostly around the waterline and to the deck. The inside of the hull is clean and well coated. Further details are in the recommendations and the plating survey plans.

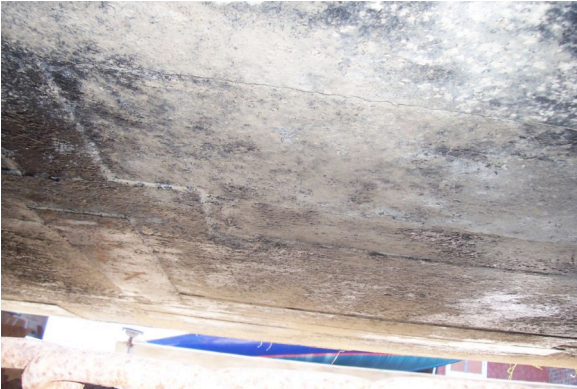
The entire bottom has been doubled with welded steel plates at various times, most recently in 2007 before she was brought to the UK. Most of this work is neatly done, although there is an area between 3m and 5m aft of the bow (shown) where numerous small plates have been welded in an ad hoc fashion. One of these is a 200mm plate which transverses the hull and a slight concavity was noted in this area. No damage was noted inside the hull.

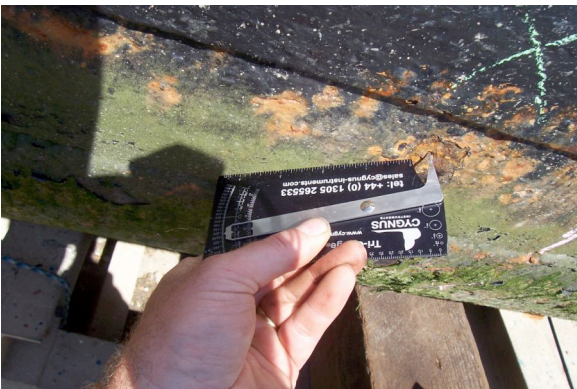
The barge was slipped at Shoreham yacht club on 30 July and the hull inspected over several days thereafter. Plates were visually inspected, hammer sounded to remove rust and thickness checked with a multiple echo ultrasonic thickness gauge which allows readings to be taken through paint coatings. Deep pits were checked with a gauge and any areas with less than 2/3 original plate thickness paint spray marked for repair. An area of corrosion and pitting was noted around the entire waterline, the pitting in places being up

to 3mm deep (shown).

In particular areas along the waterline to port (shown) between 13m and 17m aft need over plating or pad welding (A).

1. Shot blast and recoat all corroded areas along the entire waterline, including the rudder. Over plate heavily pitted areas to port from 13m to 17m aft as shown on plans and paint sprayed on the hull. Over plate two small areas of corrosion at the junction of doublers starboard aft and on the angle iron holding the skeg, also starboard aft. Recoat all surfaces with at least 6 layers of bituminous paint. (A).

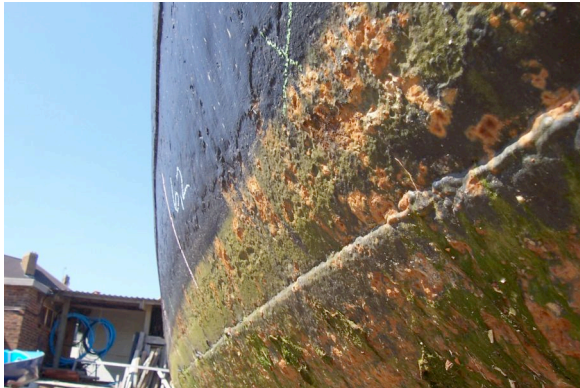
Elsewhere the paint coating along the waterline has broken down allowing corrosion beneath. The entire waterline area should be shot blasted 20cm above and below the waterline and recoated. It is important that adequate attention is given to the waterline at the bow which is close to the base of the slipway and difficult to clean and paint (A).

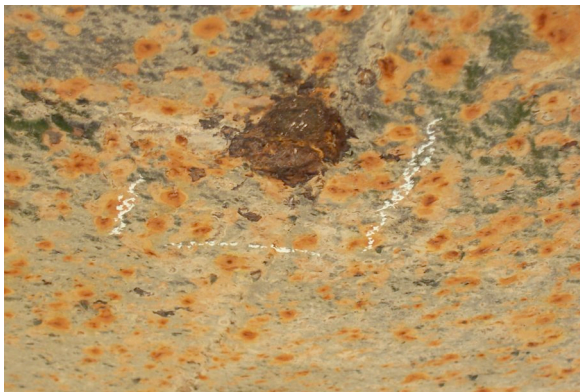
Apart from the waterline area, a small area of flaking was found at the overlap between two doublers under the stern to starboard (shown). This has been paint marked.

Where the hull is taken back to bare metal steel, it is recommend a minimum of at least six coats of bitumen paint be applied directly to the steel to provide adequate protection attention. Bitumen paint is a soft coating which must be kept well maintained. The manufacturers of Rylards 'Rytex' (already used on the rest of the hull) advise that this should be used directly on bare steel without red oxide or any other primer as the two paints are incompatible.

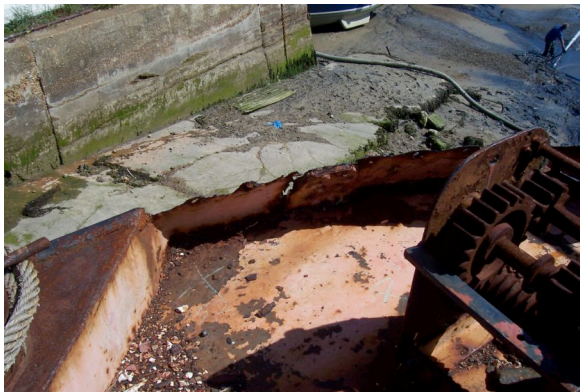
The bulwark to the stern is badly corroded (shown) and again should be cut back to firm metal and a similar repair executed (B).

1. Replace the stern bulwark plating where corroded and fit a capping piece to both this and the bow bulwark (B).
2. Remove the propeller to check for any corrosion on the shaft taper (B)
3. Remove rust from and paint the inside of the hawse pipe (B).
4. Grease, paint and re secure the anchor winch before the vessel is taken out of harbour (B).
